PRODUCT SOLUTION STORY

Discontinued Actuator Problem Solved by customizing a Standard Product

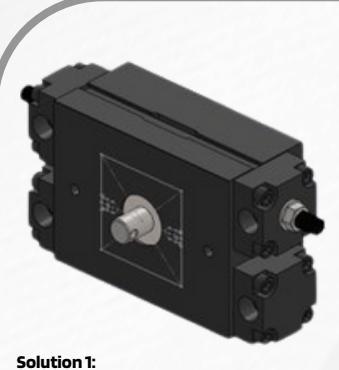
Two tapped holes were added to the front of the Rotomation A752 to accept the customer's existing mounting bracket with a small modification.

Rotomation developed two innovative solutions. For replacement, Rotomation engineers customized an actuator with a special pinion and modified mounting holes that accept the existing bracket with a minor modification. For new applications, Rotomation supplied a new bracket designed to utilize the standard actuator mounting holes along with a special pinion.

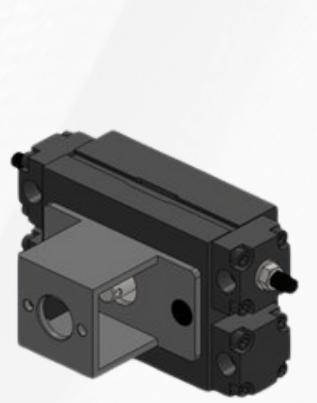
SOLUTION 2:

A new bracket was designed that is compatible with the rotary valve and attached using the two standard tapped mounting holes on the front of the actuator.
